16.0 Shiprock, New Mexico, Disposal Site

16.1 Compliance Summary

16.3.1 Annual Inspection and Report

Figure 16-1. 2003 Annual Compliance Drawing for the Shiprock, New Mexico, Disposal Site

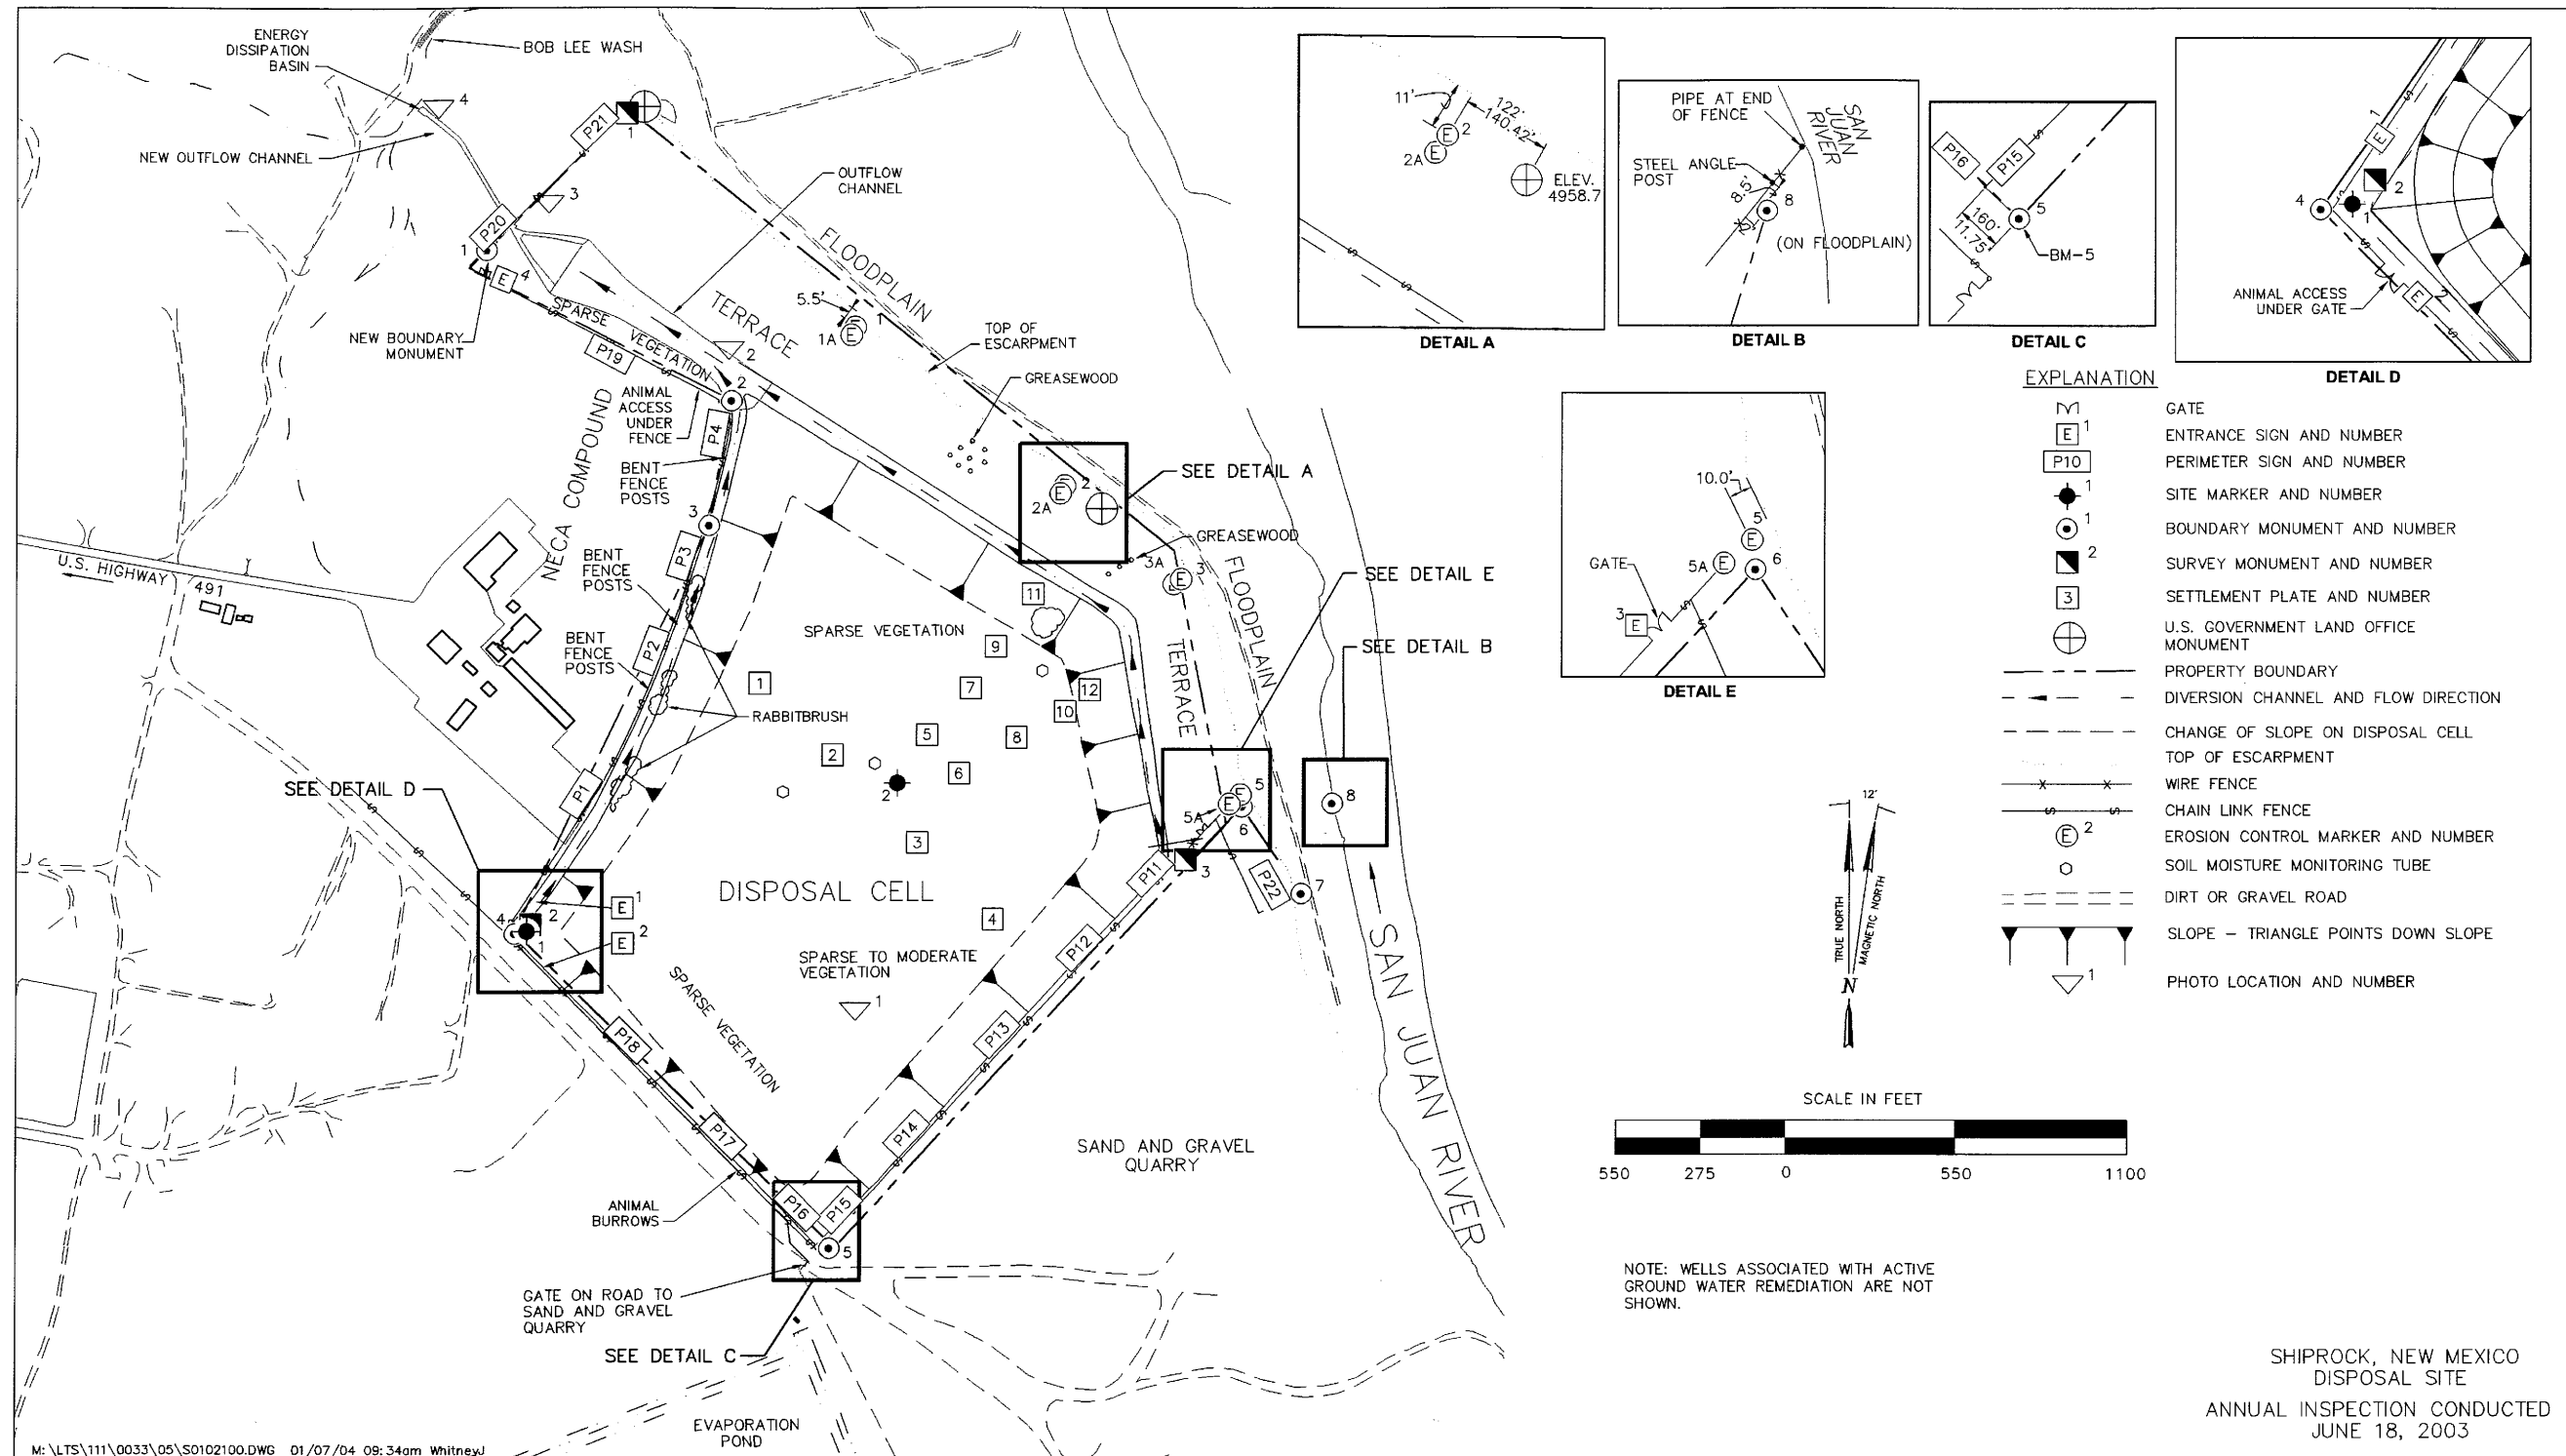
The site, located south of Shiprock, New Mexico, was inspected on June 18, 2003. Results of the inspection are described below. Features and photograph locations (PLs) mentioned in this report are shown on Figure 16–1. Numbers in the left margin refer to items in the Executive Summary table.

Diversion channels around the base of the disposal cell were in good condition. Site drainage is ultimately directed toward the outflow channel at the northwest corner of the site. Rock cover in the outflow channel was in good condition. Vegetation is increasing in the diversion and outflow channels (PL-2); however, the performance of the channels is not impaired.
